CCF Salt Marsh Planning Areas

Chatham Conservation Foundation
Salt Marsh Task Force
Gerry Stahl, Chair
May 2020

GIS Map Assessment Analysis and Results
Completed by Bryan Horsley, APCC for CCF
February 2020

Introduction to preliminary overview of CCF salt marsh planning areas

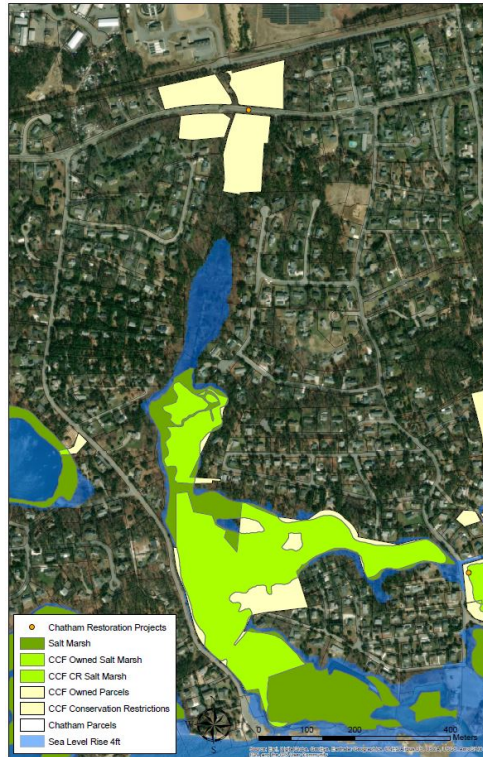
3. Cockle Cove Creek

- a. Site Description: This creek flows southward from near the Chatham transfer station into a tidal marsh area adjacent to Ridgevale Beach. After flowing beneath the Ridgevale Beach footbridge it connects with Nantucket Sound at its intersection with Buck's Creek. Based on previous field visits to this site, I recall there being significant areas of invasive common reed (*Phragmites australis*) throughout the center of this salt marsh area, which may be a target for future management activities. Poor water quality due to unacceptable bacteria levels often results in public advisory notices to avoid contact with water in this area.

- b. Salt Marsh Area: Total existing salt marsh area in this estuary totals 34.57 acres.
- c. CCF Properties: CCF owns and manages 35.18 acres of land within this estuary of which 22.69 acres are salt marsh.

- d. Restoration Sites: There is 1 restoration project site identified by the Chatham Restoration Projects data layer, which includes a combined collapsed culvert beneath route 28 and potential stormwater management to improve stream flow and water quality. CCF owns properties adjacent to this potential restoration site (north and south of Route 28). CCF also manages conservation restrictions immediately adjacent to the west of this area, thus there is substantial opportunity for improved management of stormwater in this area to benefit water quality in this creek. There is also a potential tidal restoration project at the point where a side stream of Cockle Cove Creek connects with a side stream of Bucks Creek to the east near the intersection of Ridgevale Road and Cranberry Lane. Restoration at this site could help to control nearby *Phragmites* although requires further assessment for feasibility and benefits.

- e. Salt Marsh Migration Potential: Migration potential for salt marsh likely exists upstream to the north of existing salt marsh. Much of the potential salt marsh migration area is privately owned and may be of interest for CCF to acquire.

- f. Cranberry Bogs: The Surficial Geology layer indicates that much of the existing salt marshes in Cockle Cove Creek were cranberry bogs in the past. It would be interesting to look at some marsh peat samples to see if there are layers of sand indicative of cranberry farming. This assessment could also inform future restoration activities at former cranberry bogs that are planned for tidal restoration.

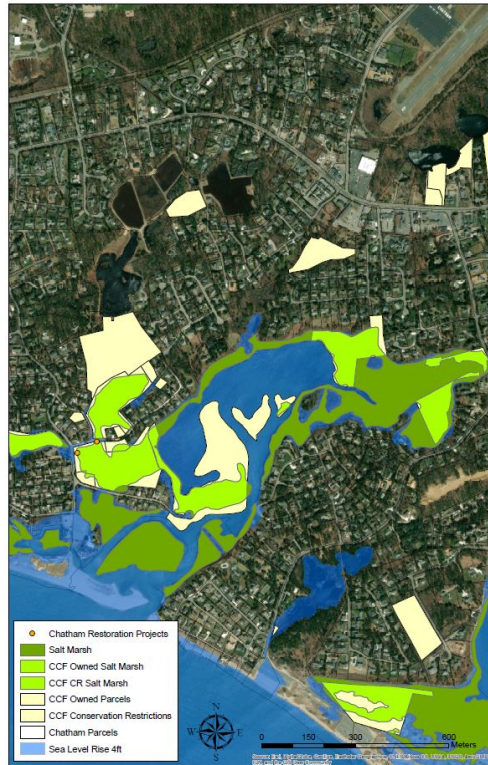
4. Bucks Creek

- a. Site Description: This creek is sourced in a complex of active cranberry bogs between Route 28 and Stephen Drive. From there it flows southward through wetlands, much of which are retired cranberry bogs and into salt marsh areas. Aerial imagery shows evidence of significant harmful cyanobacteria blooms just south of the active bogs, which is indicative of thermal stress and nutrient export associated with cranberry farming. Bucks Creek connects with Cockle Cove Creek just prior to connecting with Nantucket Sound.

- b. Salt Marsh Area: Total existing salt marsh in this system is 67.18 acres.
- c. CCF Properties: CCF manages 58.40 acres of land within and adjacent to this estuary of which 46.78 acres are salt marsh. CCF may be interested in acquiring additional properties to the north of existing properties along Bucks Creek and into areas of historic and current cranberry farming where restoration may be desirable.

- d. Restoration Opportunities: There are 2 restoration project sites identified by the Chatham Restoration Projects data layer, which are both tidal restoration projects. The first was mentioned above under Cockle Cove Creek, which would restore flow between Bucks and Cockle Cove Creeks and potentially have some positive benefit to control Phragmites. The second, which has already been addressed, helped to restore tidal flow beneath Cranberry Lane and upstream into a marsh area currently dominated by Phragmites. Just north of this area is where aerial maps appear to show cyanobacteria blooms in small ponded areas.

- e. Salt Marsh Migration Potential: The primary area of migration potential is upstream of the Cranberry Lane culvert nearly all of which CCF currently owns or holds a CR.

- f. Cranberry Bogs: Bucks Creek has substantial historic and current cranberry farming activity in areas extending from Ridgevale Road South, across aptly named Cranberry Lane and north to Route 28.

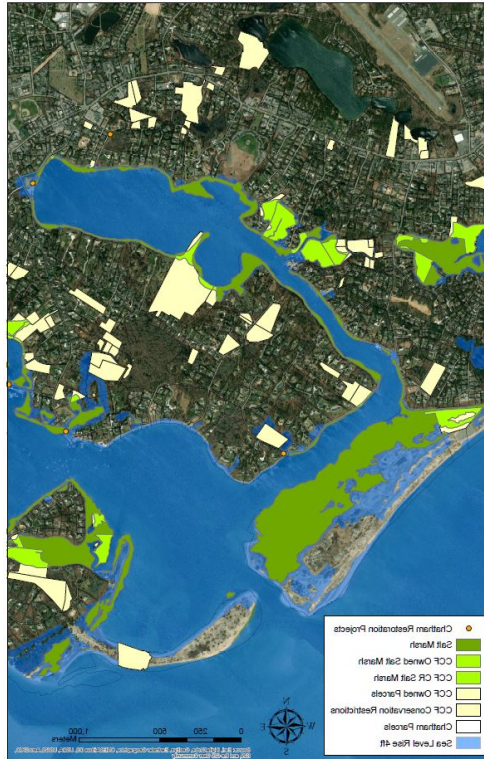
5. Oyster Pond

- a. Site Description: The Oyster Pond system extends from an open water salt pond at the northernmost point (Oyster Pond) southward through the Oyster River, which runs along the north side of Hardings Beach and eventually connects with Stage Harbor.

- b. Salt Marsh Area: The largest continuous area of salt marsh in this system is found along the inside of Hardings Beach (95.7 acres), another barrier beach, although there are multiple other smaller areas of salt marsh along the river and pond, namely two pockets of marsh on either side of Vineyard Ave. Total salt marsh in this system is 150.87 acres.

- c. CCF Properties: CCF owns 25.33 acres and manages CRs for 38.07 acres for a total of 63.40 acres of land managed within and adjacent to this system of which 25.76 acres are salt marsh.

- d. Restoration Opportunities: There are 3 restoration project sites identified by the Chatham Restoration Projects data layer, which are all stormwater remediation projects. At least one of the three projects has already been completed, although ongoing maintenance and monitoring of installed stormwater projects is essential to assure long term performance and pollution reduction. There are likely multiple other potential restoration projects in this system included a tidal restriction created by an earthen berm to the east of Vineyard Ave, Phragmites control, and additional stormwater project sites.

- e. Salt Marsh Migration Potential: Migration potential in this system appears minimal although the two marshes on either side of Vineyard Ave should be assessed in more detail as well as fringing shoreline around Oyster Pond. There is also a disconnected wetland area between Hardings Beach Road and Kemah Road that appears to be a good potential restoration and salt marsh migration site.

- f. Cranberry Bogs: The *Surfical Geography* layer indicates possible historic bogs in the wetland mentioned above along Hardings Beach Road as well as a couple small sites just north of Oyster Pond.

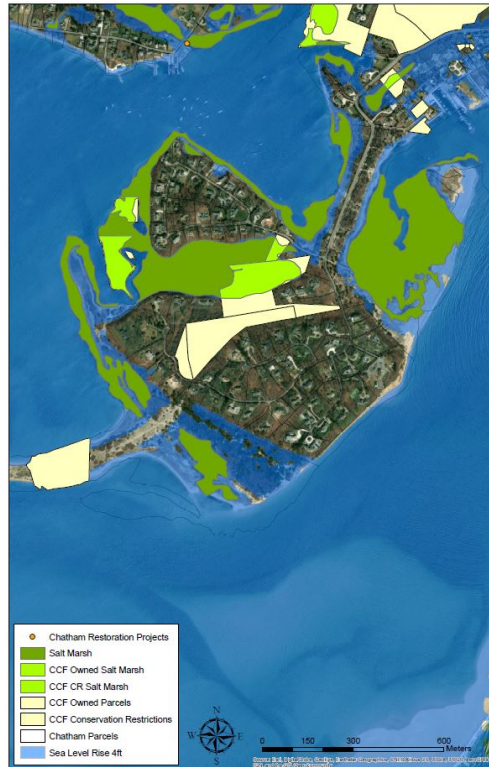
6. Morris and Stage Islands

- a. Site Description: The Morris and State Islands system is connected to the mainland via a manmade causeway to the north. Surrounding water bodies include Stage Harbor to the west, Nantucket Sound to the south, and Chatham Harbor/Atlantic Ocean to the east. The sand bars to the east are in a constant state of flux due to currents and wave energy.

- b. Salt Marsh Area: Salt marsh areas fringe the protected Stage Harbor shoreline and a pocket behind a barrier sand spit to the east of the causeway along Chatham Harbor. Total salt marsh in this system is 75.78 acres.

- c. CCF Properties: CCF owns 30.00 acres and does not manage any CRs within and adjacent to this system of which 10.07 acres are salt marsh.
- d. Restoration Opportunities: There are no restoration project sites identified in this area.

- e. Salt Marsh Migration Potential: There are a couple significant areas for possible marsh migration including much of the southern end of Morris Island and a detached wetland (maybe currently a cedar swamp?) in the northern center of Morris Island. This latter area may require some assistance to facilitate tidal flow if deemed a desirable project. Note that the inland area does not show up on our GIS map but is clearly apparent with 4ft of SLR on the Cape Cod Commission's SLR Viewer tool.

- f. Cranberry Bogs: The three bog layers do not indicate any current or past cranberry farming activity on these islands.

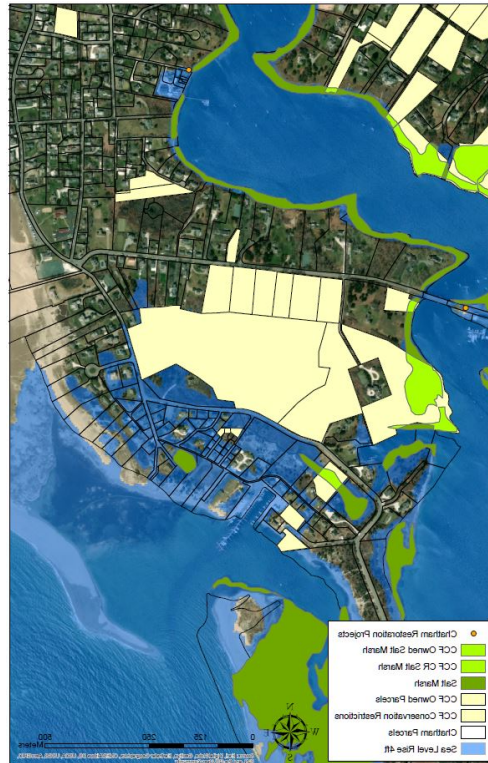
7. Toms Neck

- Site Description:** Toms Neck is a land area north of the Morris Island causeway and south of the Chatham lighthouse. Surrounding water bodies include Mill Pond and Stage Harbor to the north and west and Chatham Harbor and the Atlantic Ocean to the east. Much of the center of this land area is dominated by a low-lying wetland area and flooding of residential properties and roads has been an increasing issue in recent years.

- Salt Marsh Area:** Salt marsh areas fringe the protected waters of Mill Pond and Stage Harbor shorelines and a couple small pockets on the southern end of the landmass. Total salt marsh in this system is 9.53 acres.

- CCF Properties:** CCF owns 54.50 acres and manages 0.69 acres of CRs within and adjacent to this system for a total of 55.19 acres of which 4.69 acres are salt marsh. Much of the low-lying interior land of Toms Neck is owned by CCF, which is also a large area of potential salt marsh migration. Restoration opportunities and additional property acquisitions should be explored in this area.

- Restoration Opportunities:** There are no restoration project sites identified in this area.
- Salt Marsh Migration Potential:** Due to low lying nature of much of this landmass, much of Toms Neck could allow for future marsh migration potential. Unfortunately, SLR will likely require many homes, cottages, and infrastructure to be removed from this area. But fortunately, this area may become a large salt marsh area in the future.

- Cranberry Bogs:** The three bog layers do not indicate any current or past cranberry farming activity in this area.

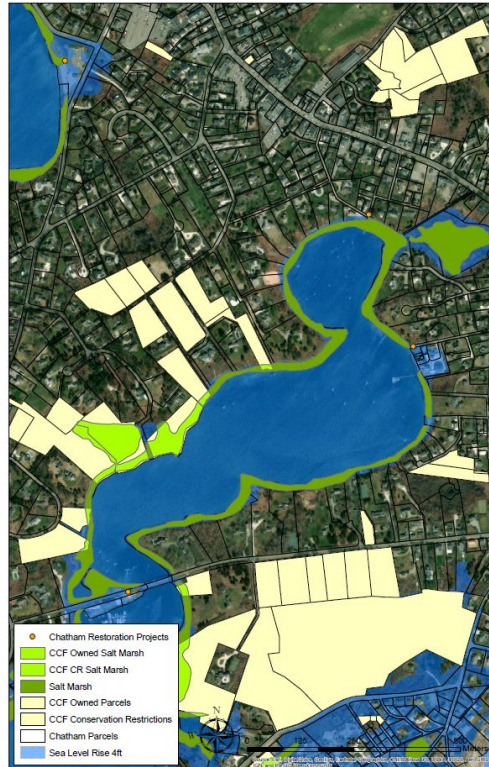
8. Mill Pond

- Site Description:** Mill Pond is a salt water body to the north of Toms Neck which is connected to Nantucket Sound through Stage Harbor to the south. Bridge Street crosses the channel between Mill Pond and Stage Harbor and allows boat passage beneath a newly rebuilt wooden draw bridge. While there may be a small restriction to tidal flow here it appears minimal at most.

- Salt Marsh Area:** Salt marsh areas fringe the protected waters of Mill Pond and there are a couple larger pockets of salt marsh, namely to the west adjacent to Elizabeth's Way and in the north near the intersection of Main Street and School Street. Total salt marsh in this system is 18.74 acres.

- CCF Properties:** CCF owns 34.9 acres and manages 2.23 acres of CRs within and adjacent to this system for a total of 37.13 acres of which 4.56 acres are salt marsh.

- Restoration Opportunities:** There are 3 restoration project sites identified in this area all of which are stormwater management projects. Current status of these projects is unknown.

- Salt Marsh Migration Potential:** Migration potential in this area appears to be limited due to elevation and surrounding development and infrastructure. There are a couple areas of possible migration on the south west of Mill Pond. The first is just north of Bridge Road on the west edge of the water and the second is just a bit further north on the same western shoreline. CCF owns much of the area for both opportunities and should consider managing them with SLR and marsh migration in mind. There also appears to be some potential for migration surrounding the pocket marsh area on the northern end of Mill Pond.

- Cranberry Bogs:** The three bog layers do not indicate any current or past cranberry farming activity in this area.

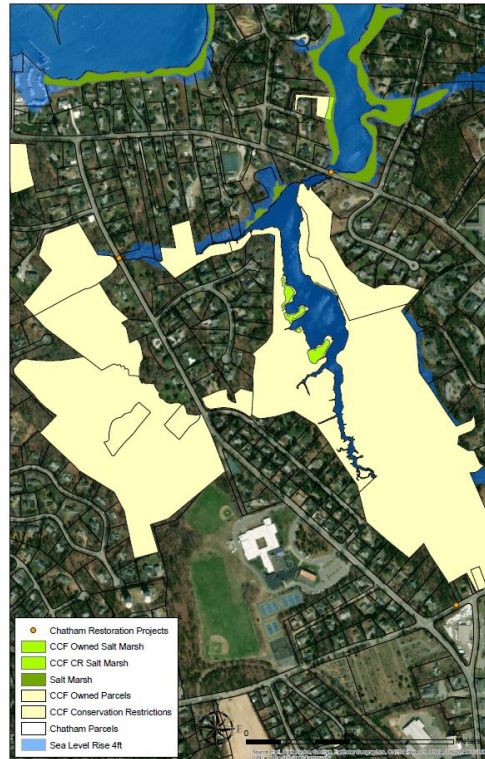
9. Frost Fish Creek

- a. Site Description: Frost Fish Creek is a complex tidal estuary that's hydraulically connected to Ryders Cove via a series of culverts beneath Route 28 and an earthen berm. The open water area branches to the west and narrows to a small stream beneath Crowell Road, and extends all the way to Lovers Lake. The main open water area continues southward where it narrows and ends at a concrete water control structure that blocks tidal influence from a large fresh bog area. APCC and CCF have worked together to assess this estuary as a possible site for tidal restoration to improve water quality and wildlife habitat. APCC conducted initial field work and wrote a restoration assessment report for CCF in early 2019.

- b. Salt Marsh Area: Salt marsh areas are patchy along the shorelines of the protected waters of Frost Fish Creek, although the restrictions to tidal flow have likely drastically reduced salt marsh area here compared with previous, unrestricted extent. Total salt marsh in this system, according to an initial field survey by APCC is 0.95 acres. APCC field survey also identified 2.30 acres of *Phragmites* within Frost Fish Creek and the upper bog area, some of which may also be classified as salt marsh.

- c. CCF Properties: CCF owns the majority of the land surrounding Frost Fish Creek for a total of 88.34 acres of which 0.67 acres are salt marsh. There are no CCF managed CRs within this area.

- d. Restoration Opportunities: There are 3 restoration project sites identified in this area all of which are tidal restoration projects. None of these projects have been addressed, although CCF and APCC have conducted an initial restoration assessment and are working with partners to further develop this project. In addition to tidal restoration work there are also a few sites where stormwater remediation would benefit water quality including along Crowell Road, Route 28 and Stony Hill Road. Low-lying residential properties are likely to create challenges for a full tidal restoration. To address this challenge, CCF may want to consider acquiring available properties within areas likely to be flooded by tidal restoration.

- e. Salt Marsh Migration Potential: There is substantial salt marsh migration potential within Frost Fish Creek, although completion of the proposed tidal restoration projects will be necessary to allow adequate tidal flow into the system to restore and expand salt marsh areas. Largest areas of marsh migration include the southern bog area and currently forested areas west of Crowell Road.

- f. Cranberry Bogs: Most of the land surrounding Frost Fish Creek was historically farmed for cranberries. This is the reason for installation of the many tidal restrictions and water control structures in this area.

- g. Restoration Priority: Frost Fish Creek is CCF's initial salt marsh restoration project. CCF contracted with APCC to conduct a preliminary study in 2018 for \$5,000. The study concluded that there were multiple tidal restrictions and

substantial salt marsh migration potential, warranting further investigation. CCF submitted a CPC proposal for \$75,000 to conduct two detailed studies (complete hydraulic and hydrologic modeling and complete water quality modeling, based on that), to be supervised by APCC. CCF is providing a \$5,000 match to this grant. The proposal was supported by the Pleasant Bay Association, APCC and the Town of Chatham; it was endorsed by CPC, the Chatham Board of Selectmen and the Chatham Finance Committee. It is expected to be approved at Town Meeting in September 2020.

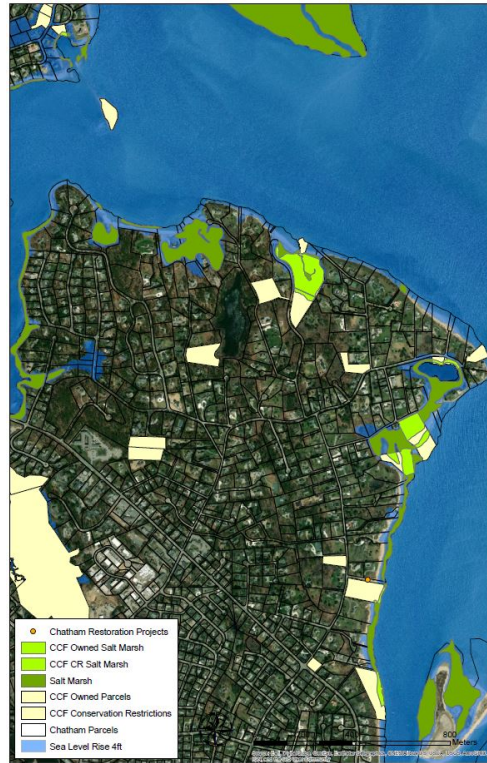
10. North Chatham

- Site Description:** This site is comprised of a large lobe of land extending from Route 28 northward into Pleasant Bay. Lower Frost Fish Creek and Ryders Cove frame the western shorelines with Bassing Harbor to the north and Chatham Harbor to the east.

- Salt Marsh Area:** Salt marsh areas fringe much of the shorelines of this area with a few pockets of larger marsh areas throughout. Total salt marsh in this system is 32.59 acres.

- CCF Properties:** CCF owns 20.92 acres and manages 7.06 acres of CRs in this area for a total of 27.98 acres of which 9.05 acres are salt marsh.
- Restoration Opportunities:** There is 1 restoration project sites identified in this area which is a stormwater management project at Cow Yard Road. Current status of this project is unknown.

- Salt Marsh Migration Potential:** There appears to be some marsh migration potential in this area including an area extending from upper Frost Fish Creek to the east into North Chatham, fringing areas around many of the pocket marshes along the northern and eastern shorelines, and a significant area in the middle of the landmass, which appears to currently be a shallow wetland dominated by open water and algae growth. Note that SLR flooding of this area was observed using the Cape Cod Commission's SLR Viewer tool and does not show up with the *Sea Level Rise 4ft* layer included in our GIS. CCF manages land in many of these potential migration areas although none are managed in the area where Frost Fish Creek appears to have potential to extend eastward with SLR of 4ft. This may be a desirable area for future land acquisitions.

- Cranberry Bogs:** There are a few areas of historic cranberry farming activity in North Chatham. Most notable is the large wetland area in the center of the landmass that was described as a potential marsh migration area above.

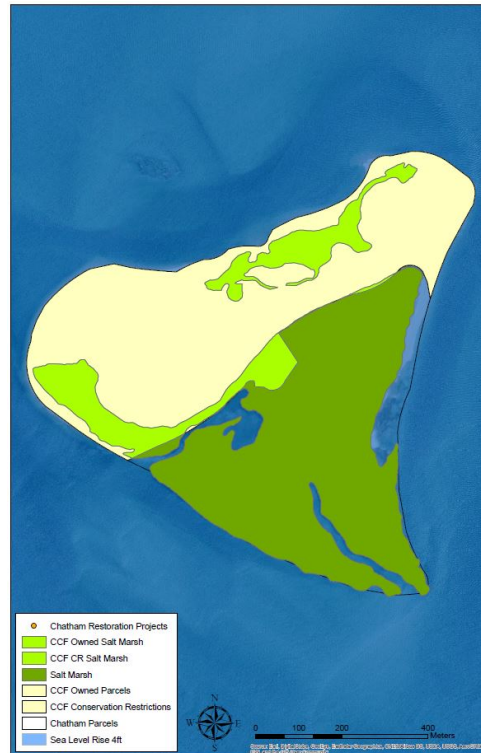
11. Strong Island

- Site Description:** This site is comprised of an island within Pleasant Bay. The island exists to the north of North Chatham and is not connected to the mainland. The northern upland portions of the island have steep gradients and significant elevation above sea level. It's notable that this island is very much shaped like a shark tooth.

- Salt Marsh Area:** Roughly half of this island is comprised of salt marsh with the majority being on the southern end. Total salt marsh in this system is 75.52 acres.

- CCF Properties:** CCF owns the entirety of the upland portion of the island at a total of 79.39 of which 16.51 acres is salt marsh. The CCF may want to consider adding the southern salt marsh area as part of their acquisition.

- Restoration Opportunities:** There are no restoration project sites identified in this area and the island is mostly undeveloped, aside from a single home and outbuildings so restoration needs are likely minimal. The island should be surveyed for invasive vegetation.

- Salt Marsh Migration Potential:** There appears to be minimal opportunity for marsh migration on this island due to steep gradients and relatively high elevation of the northern upland landmass. This is one of the few marshes on Cape Cod that has not been extensively ditched and impacted by human activities and thus is of very high value to preserve and protect. Proposed dredging projects should be watched closely to assure deepening of adjacent boating channels won't increase undercutting and calving of salt marsh peat, which is mostly not protected by barrier beach or any significant natural structures.

- Cranberry Bogs:** There is no evidence of historic cranberry farming on this island.

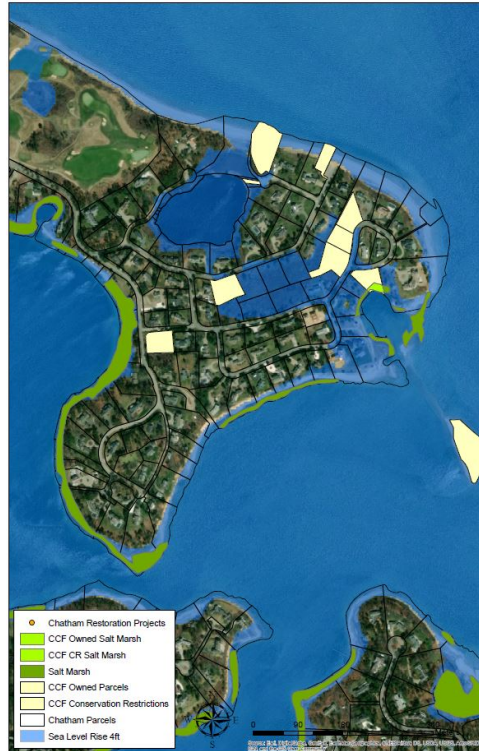
12. Nickersons Neck

- a. Site Description: This site is comprised of a peninsula between Crows Pond and Pleasant Bay to the west of Strong Island. Much of the western portion of the land area is covered by the Easward Ho! Golf course and the eastern portion is residential. There's an open water wetland very close to the Pleasant Bay shoreline on the northern part of the neck.

- b. Salt Marsh Area: Salt marsh fringes much of the southern and eastern shorelines. Total salt marsh in this system is 8.29 acres.
- c. CCF Properties: CCF owned parcels cover a total area of 5.91 acres of which 0.10 acres is salt marsh. CCF does not manage any CRs in this area.

- d. Restoration Opportunities: There are no restoration project sites identified in this area.
- e. Salt Marsh Migration Potential: There appears to be some opportunity for marsh migration in this area. While the eastern end of the neck is low-lying and will flood with 4ft of SLR, there are roads and homes that will present challenges. Best migration areas include two wetland areas with the first between Strong Island Road and Eastward Road and the second north of Strong Island Road. CCF may want to consider additional property acquisitions in these areas of possible marsh migration.

- f. Cranberry Bogs: There is no evidence of historic cranberry farming on this peninsula.

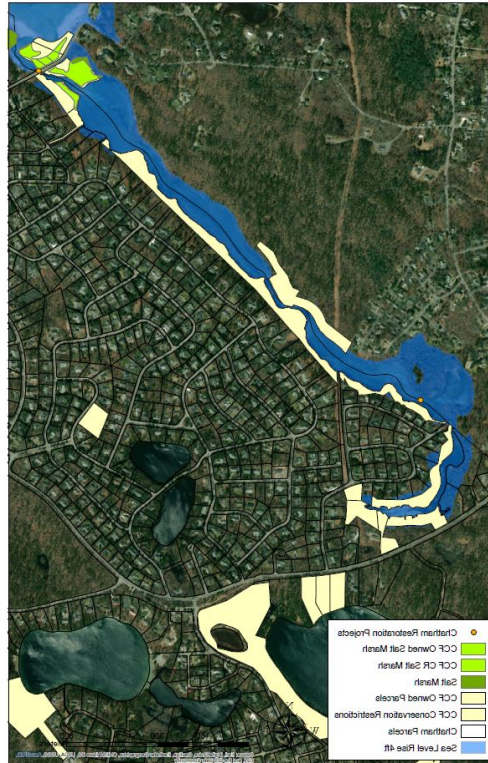
13. Muddy Creek

- a. Site Description: Muddy Creek is a long and narrow tidal estuary that extends from the southwest corner of Big Pleasant Bay at Route 28 southwestward along the Chatham-Harwich border.

- b. Salt Marsh Area: According to our data layer, salt marsh is limited to a small area on the north end of this system. Total salt marsh indicated in this system is 2.20 acres. Current day salt marsh area is likely significantly larger than this due to a recent tidal restoration that has successfully increased tidal exchange, water quality, salinity and associated health and expansion of salt marsh areas south of Route 28.

- c. CCF Properties: CCF owned parcels cover a total area of 22.35 acres and manages CRs for 5.81 acres for a total of 28.16 acres of which 1.95 acres is salt marsh.

- d. Restoration Opportunities: There are 2 restoration project sites identified in this area. The first has been completed, as discussed above, to restore tidal flow beneath Route 28. The second entails a possible fish passage restoration at the southern end of the system to facilitate migratory fish passage to spawning grounds. Additional tidal restoration work may also be desirable in the future as there are few sites where earthen berms restrict flow through the system.

- e. Salt Marsh Migration Potential: There appears to be some opportunity for marsh migration in this area although it is limited due to elevation of surrounding land. Since the tidal restoration was completed salt marsh area is expanding and SLR will likely drive further expansion up the creek banks and into some low-lying areas in the southern reaches of the system.

- f. Cranberry Bogs: There are a few areas of likely historic cranberry farming in the southern end of Muddy Creek and the remaining earthen berms are evidence of this past activity.

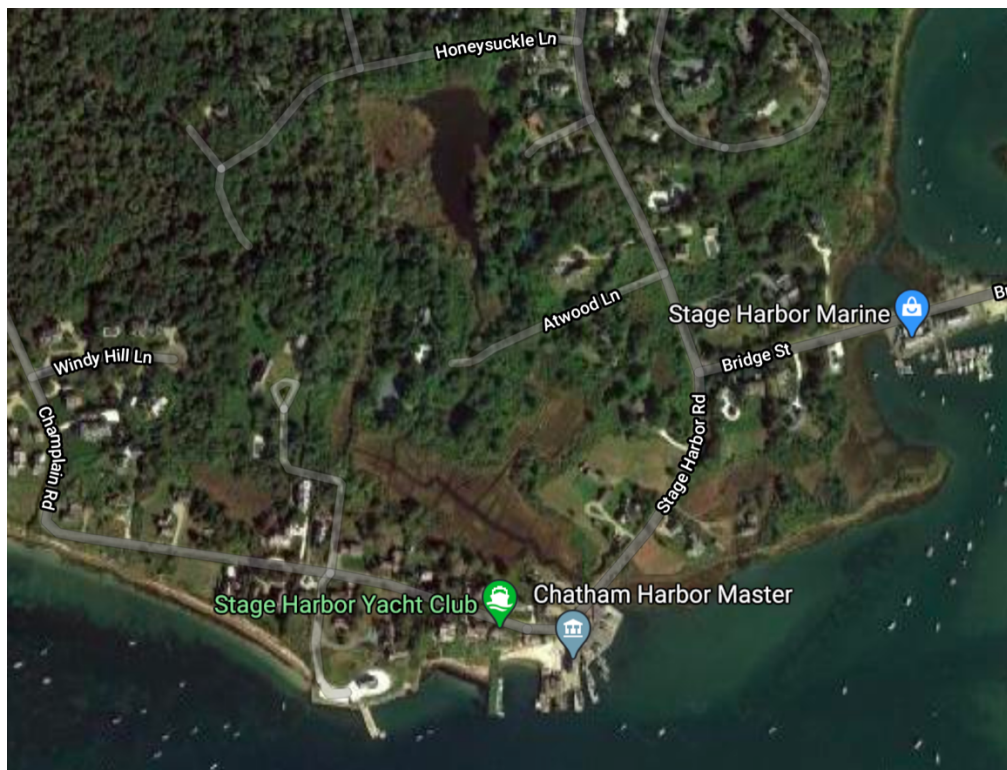
14. Champlain Creek

Champlain Creek flows inland from Stage harbor at the mouth of Mill Pond.

Tidal flow to the 4.3 acre Champlain Creek Salt Marsh is severely restricted by an undersized and dilapidated 20 inch diameter metal culvert. Replacement of the undersized and failing culvert will re-introduce tidal hydrology to the site, restoring the former salt marsh.
